**Albatross Equipment Earthworks**  
10998 WY-789 Riverton, WY 82501  
[www.albatrossequipment.com](http://www.albatrossequipment.com)

## **Inspection Checklist for 2009 CATERPILLAR 966H**

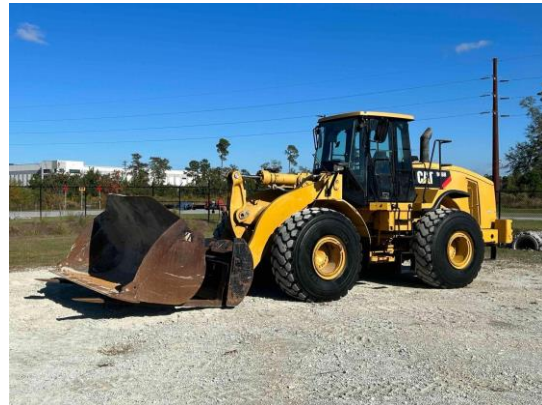
- The 2009 Caterpillar 966H Wheel Loader is in **\*\*good condition\*\***. Regular maintenance has been observed, and the machine is fully operational with no significant issues. It is ready for immediate use.
