Albatross Equipment Earthworks
10998 WY-789 Riverton, WY 82501
www.albatrossequipment.com

Inspection Checklist for 2016 JCB 509-42

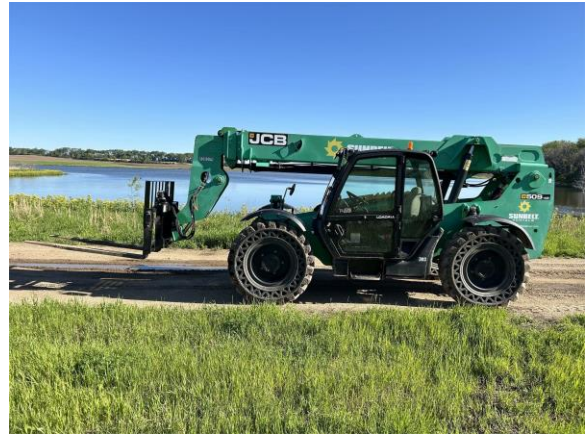
- - Overall Condition: Good, no significant damage or excessive wear observed. Machine shows normal signs of use.
- - Serial Number: Verified during inspection (available upon request).
- - Visual Inspection: Clean exterior with minor cosmetic wear consistent with hours.

- - The 2016 JCB 509-42 Telehandler is in Good Condition with no major mechanical or structural issues. Minor wear is consistent with the machine's hours.
- - Recommended Maintenance: Routine service as per manufacturer's schedule to maintain optimal performance. No immediate repairs required.
