Albatross Equipment Earthworks
10998 WY-789 Riverton, WY 82501
www.albatrossequipment.com

Inspection Checklist for 2017 Kubota KX080-4

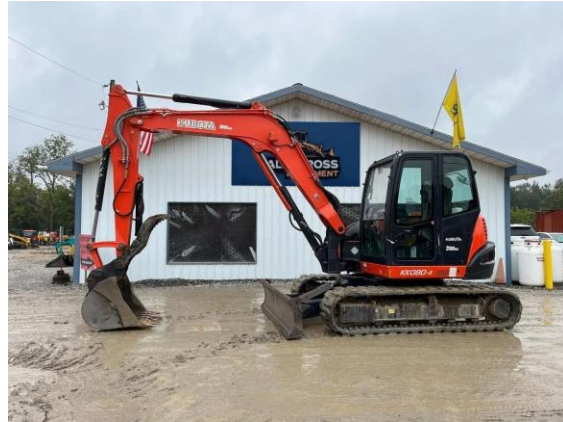
The 2017 Kubota KX080-4 has been inspected thoroughly and is in good condition, with all major systems and components functioning properly. Minor wear consistent with machine age and hours was noted, but no significant defects or maintenance concerns were identified. This excavator is work-ready and requires no immediate repairs.
