**Albatross Equipment Earthworks**  
10998 WY-789 Riverton, WY 82501  
[www.albatrossequipment.com](http://www.albatrossequipment.com)

## **Inspection Checklist for 2018 Bobcat T770**

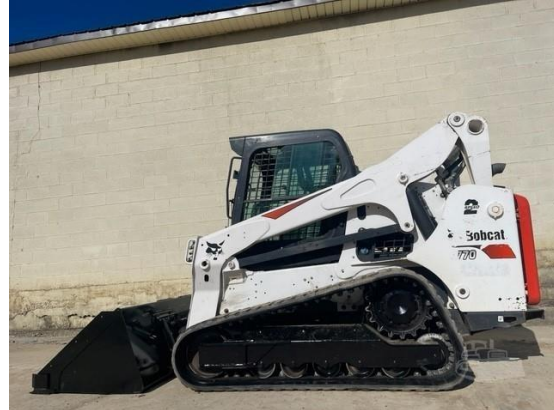
The **2018 Bobcat T770** is in **GOOD CONDITION** with **low hours** relative to its age. This machine demonstrates reliable performance across all key systems. The hydraulic system is leak-free, and the tracks have substantial life remaining (85%). The cab is in excellent shape, and all controls, heat, and A/C function as expected. With its powerful 92 HP engine and additional features like a quick attach mechanism, this unit is well-prepared for immediate use in demanding applications.

Overall Condition: 90%
