**Albatross Equipment Earthworks**  
10998 WY-789 Riverton, WY 82501  
[www.albatrossequipment.com](http://www.albatrossequipment.com)

## Inspection Checklist for 2019 JCB 509-42

### Completed Inspection Checklist

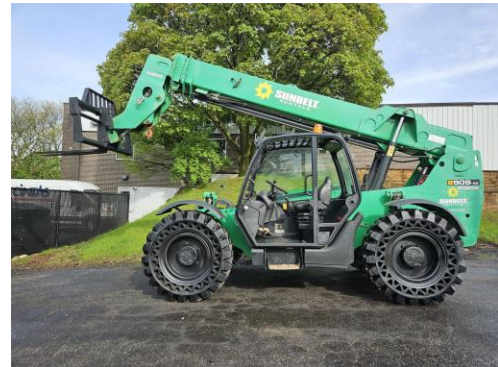
- Overall Appearance: The telehandler shows signs of normal wear consistent with its hours of operation. Exterior panels and paint are intact, with minor scratches and no structural damage.
- Chassis and Frame: Frame inspected for cracks or deformations: No issues detected. Welds inspected: All welds in factory condition, no repairs or modifications.

The 2019 JCB 509-42 is in good overall condition, with all major systems operating properly. Minor wear observed is consistent with the machine's age and hours. The telehandler is work-ready and does not require immediate maintenance or repairs.
