Albatross Equipment Earthworks
10998 WY-789 Riverton, WY 82501
www.albatrossequipment.com

Inspection Checklist for 2019 Kubota KX057-4

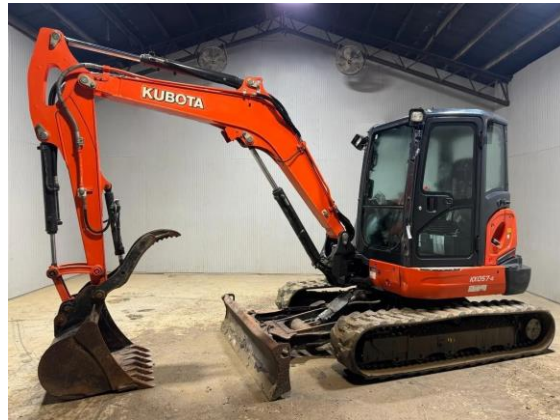
The 2019 Kubota KX057-4 has been inspected and is in ****good operational condition****. Minor wear on tracks and working components is consistent with its hours of use. No major repairs or immediate maintenance needs were identified. This excavator is ready for continued service.
