Inspection Checklist for 2019 KUBOTA KX033-4

- **Model Name:** 2019 Kubota KX033-4
- **Hours:** 626
- **Condition:** Good
- **Features:** Enclosed cab, AB float angle blade, 2-speed travel, operation pattern changer, hydraulic thumb, 36" bucket

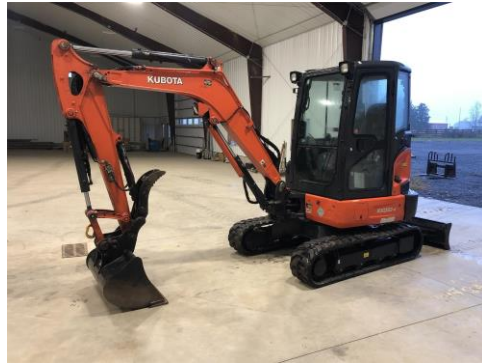
The 2019 Kubota KX033-4 is in ****good condition**** with no significant issues. Routine maintenance is up to date, and all components function as expected. Tracks and bucket show moderate wear but remain serviceable. The machine is fully operational and work-ready.
