Albatross Equipment Earthworks
10998 WY-789 Riverton, WY 82501
www.albatrossequipment.com

Inspection Checklist for 2021 BOBCAT MT100

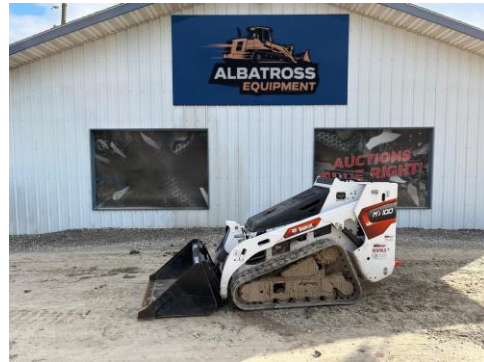
Overall condition rated as Good, with minimal wear and no major defects. Ready for immediate work.
