Albatross Equipment Earthworks
10998 WY-789 Riverton, WY 82501
www.albatrosequipment.com

Inspection Checklist for 2022 Caterpillar 906M

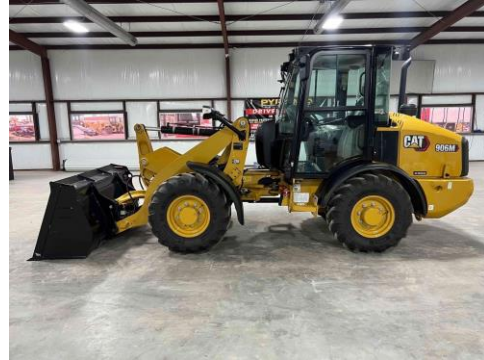
- This 2022 Caterpillar 906M is in excellent condition, reflecting its low-hour usage (8 hours). All systems have been thoroughly inspected and tested, with no issues or repairs needed. The machine is work-ready and meets all safety and performance standards.
