**Albatross Equipment Earthworks**  
10998 WY-789 Riverton, WY 82501  
[www.albatrossequipment.com](http://www.albatrossequipment.com)

## Inspection Checklist for 2022 KUBOTA KX033-4

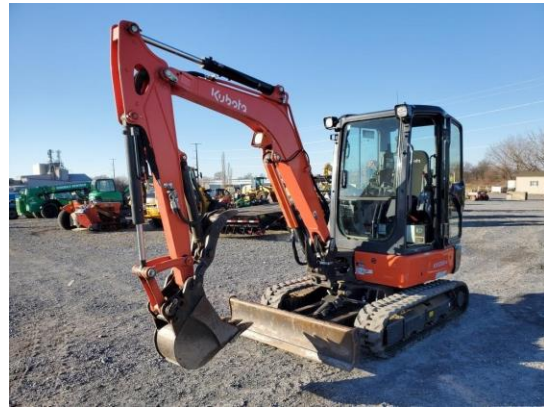
**\*\*Overall Appearance\*\*:** Good condition; minor cosmetic wear consistent with hours. Paint intact with no significant scratches or dents.
