**Albatross Equipment Earthworks**  
10998 WY-789 Riverton, WY 82501  
[www.albatrossequipment.com](http://www.albatrossequipment.com)

## **Inspection Checklist for 2022 KUBOTA U27-4**

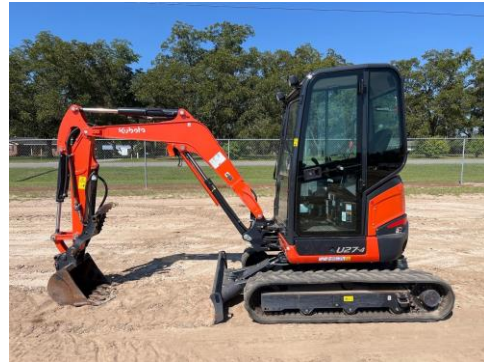
The 2022 Kubota U27-4 is in good condition with no significant issues detected. Routine maintenance is up to date, and the excavator is ready for immediate operation. Minor wear consistent with its usage hours is present but does not impact performance or reliability.
