Inspection Checklist for 2018 New Holland C237

Model: 2018 New Holland C237
Machine Hours: 765 Hours
Condition: Good

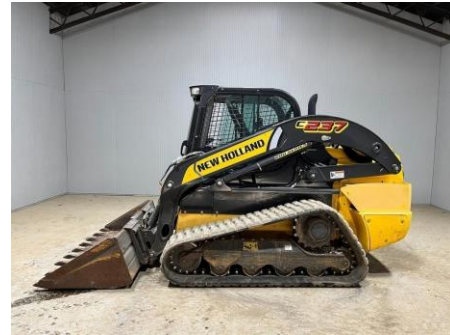
The **2018 New Holland C237 Skid Steer** is in **good condition** with **765 hours** on the clock. All systems are fully functional with minor wear consistent with its operational hours. No significant repairs are needed at this time, though the bucket shows slight wear on the cutting edge.
