Albatross Equipment Earthworks
10998 WY-789 Riverton, WY 82501
www.albatrossequipment.com

Inspection Checklist for 2019 Caterpillar 289D

- Model: 2019 Caterpillar 289D
- Hours: 3,009
- Condition: Good
- Features: Rubber tracks, EROPS, 2-speed travel, hydraulic quick-attach bucket, auxiliary valves.

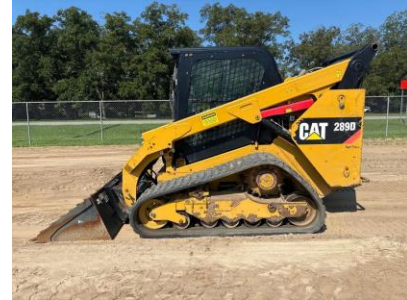
The 2019 Caterpillar 289D Skidsteer is in good condition, with all major components functioning as intended. Minor cosmetic wear is present but does not affect operational performance. This machine is work-ready and suitable for immediate deployment.
