Inspection Checklist for 2019 DEERE 314G

Model Name: 2019 DEERE 314G
Machine Hours: 315
Condition: Excellent (95%)

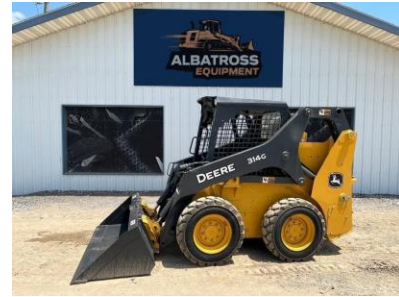
The 2019 DEERE 314G Skid Steer with 315 machine hours is in excellent working condition, with minimal wear and no significant issues. All components and systems are functioning as expected, and the machine is ready for immediate use.
