Inspection Checklist for 2020 CATERPILLAR 239D3

- **Make and Model:** 2020 CATERPILLAR 239D3
- **Machine Hours:** 906
- **Condition:** Good

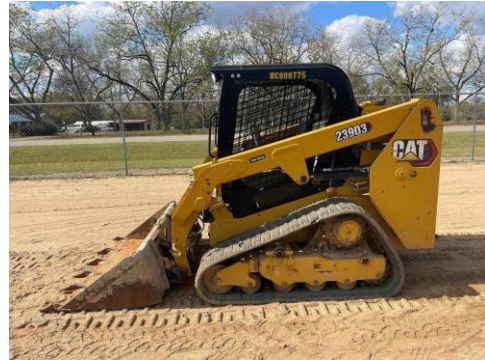
The 2020 CATERPILLAR 239D3 Skidsteer is in **good working condition** with minor wear consistent with hours and age. Key systems, including the engine, hydraulics, and operator controls, function as intended. No significant repairs are required at this time. Routine maintenance is up to date, and the machine is ready for work.
