**Albatross Equipment Earthworks**  
10998 WY-789 Riverton, WY 82501  
[www.albatrossequipment.com](http://www.albatrossequipment.com)

## **Inspection Checklist for 2021 KUBOTA SCL1000**

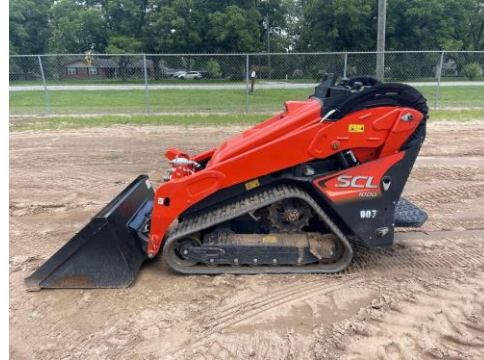
- Overall Appearance: Equipment shows minimal signs of use; paint and body panels in good condition with minor cosmetic wear consistent with hours.
- Serial Plate: Fully intact and legible.

The 2021 KUBOTA SCL1000 is in good condition with all primary systems fully operational. Minor cosmetic wear is consistent with 288 operating hours. The equipment is work-ready and meets industry standards for reliability and safety.
