Albatross Equipment Earthworks
10998 WY-789 Riverton, WY 82501
www.albatrossequipment.com

Inspection Checklist for 2021 Kubota SCL1000

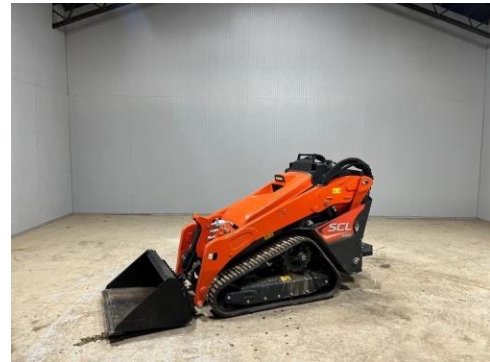
- The 2021 Kubota SCL1000 is in Good Condition, with minimal wear consistent with 119 hours of operation. No immediate repairs or replacements are needed. All components are fully operational, making this machine work-ready for a variety of tasks.
