Albatross Equipment Earthworks
10998 WY-789 Riverton, WY 82501
www.albatrossequipment.com

Inspection Checklist for 2022 CASE TR270B

- **Model:** 2022 CASE TR270B
- **Machine Hours:** 675
- **Condition:** Good

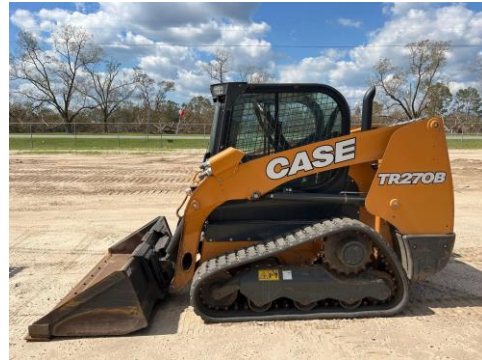
The 2022 CASE TR270B is in **good working condition** with no significant mechanical or structural issues. The machine is ready for work, with minor cosmetic wear and standard maintenance items in line with usage. Regular servicing and inspections have preserved the machine's functionality and performance.
