Inspection Checklist for 2022 Caterpillar 299D3

Model: 2022 Caterpillar 299D3

Hours: 827

Condition: Good Condition

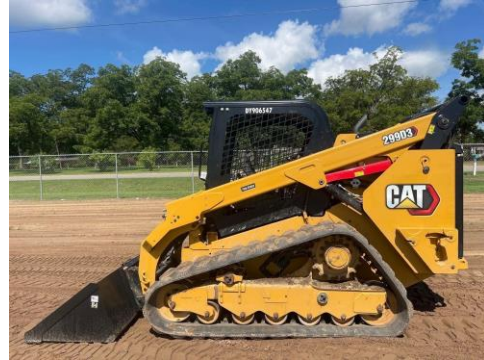
- Condition Summary: This 2022 Caterpillar 299D3 is in good condition with minor wear consistent with 827 operating hours. All major systems, including hydraulics, drivetrain, and engine, are functional and free from significant issues.

- Recommendation: Machine is work-ready and requires no immediate repairs. Routine maintenance as per manufacturer recommendations is advised.
