## Inspection Checklist for 1993 John Deere 4960

**Model:** John Deere 4960  
**Year:** 1993  
**Machine Hours:** 2,616  
**Overall Condition:** Very Good

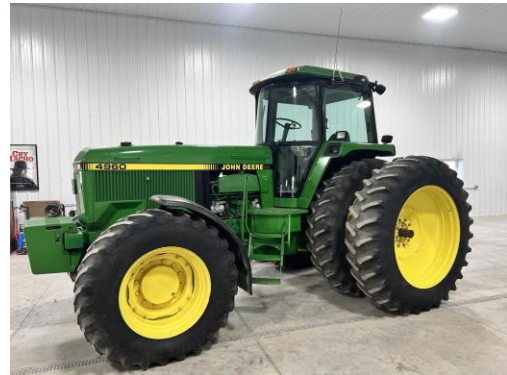
This 1993 John Deere 4960 tractor is in very good condition, reflecting its low usage and proper maintenance. It is well-suited for continued agricultural use with no immediate concerns.
