Albatross Equipment Earthworks
10998 WY-789 Riverton, WY 82501
www.albatrossequipment.com

Inspection Checklist for 2014 CATERPILLAR 416F

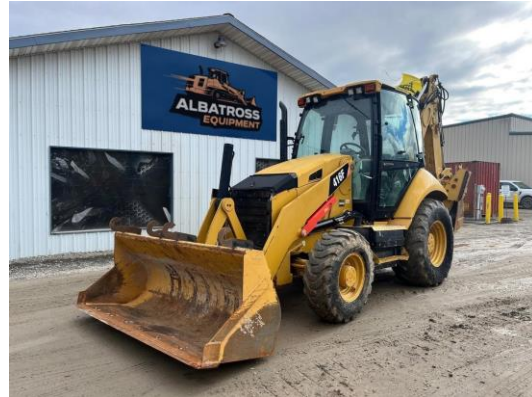
- Overall condition rated at 90%; machine is well-maintained with minimal wear considering usage hours.
- No immediate repairs or replacements required.
- Ready for work with no operational restrictions.
