Albatross Equipment Earthworks
10998 WY-789 Riverton, WY 82501
www.albatrossequipment.com

Inspection Checklist for 2014 CATERPILLAR 420F IT

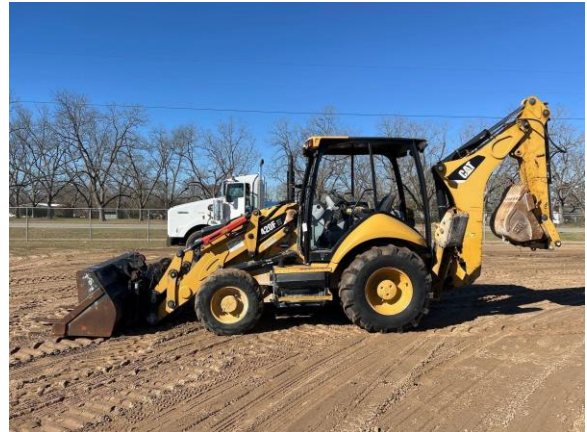
This 2014 CATERPILLAR 420F IT Backhoe Loader is in good condition (90%) with low hours (1,638). All systems and components are operational, and no major defects or issues were identified. This equipment is work-ready and suitable for a variety of tasks.
