Albatross Equipment Earthworks
10998 WY-789 Riverton, WY 82501
www.albatrossequipment.com

Inspection Checklist for 2015 DEERE 410L

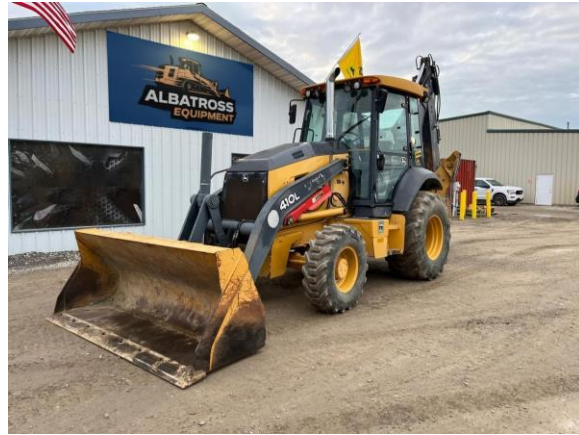
The 2015 DEERE 410L is in ****good condition (90%)****. It has been well-maintained with no critical issues detected during inspection. Minor wear on hydraulic seals and tires is consistent with usage hours and does not affect functionality. This machine is ****work-ready**** and suitable for immediate deployment.
