Inspection Checklist for 2016 DEERE 450J LGP

- **Make/Model:** 2016 DEERE 450J LGP
- **Machine Hours:** 3,802
- **Operating Weight:** 17,562 lbs
- **Engine:** 74 HP Diesel Engine
- **Blade:** 6-Way Hydraulic Blade
- **Transmission:** Power Shift Transmission
- **ROPS:** Canopy

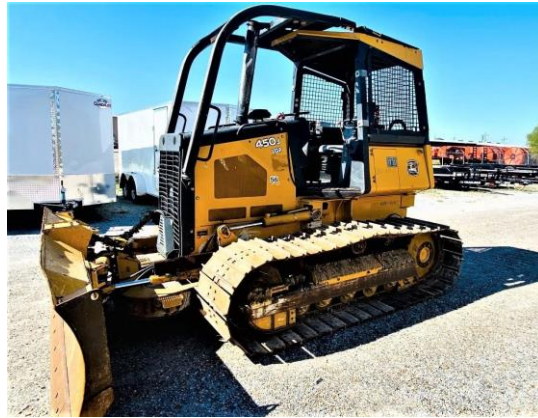
- The 2016 DEERE 450J LGP bulldozer has been thoroughly inspected and found to be in good operating condition with minor wear typical for its hours (3,802). The machine runs and operates as expected, and critical components such as the engine, transmission, hydraulics, and undercarriage are in excellent working order.
- Minor recommendations include monitoring blade cutting edge wear and track shoe condition for future replacement.
- This bulldozer is work-ready and performs to manufacturer specifications.
