**Albatross Equipment Earthworks**  
10998 WY-789 Riverton, WY 82501  
[www.albatrossequipment.com](http://www.albatrossequipment.com)

## **Inspection Checklist for 2018 John Deere 85G**

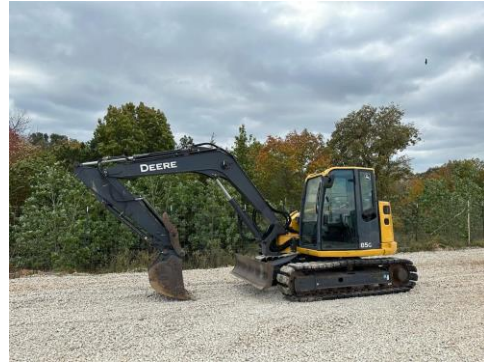
The 2018 DEERE 85G excavator is in good overall condition. All critical components are operational, with no major defects or immediate maintenance needs. The machine is well-suited for job site applications, and its clean condition reflects proper maintenance practices.
