Albatross Equipment Earthworks
10998 WY-789 Riverton, WY 82501
www.albatrossequipment.com

Inspection Checklist for 2018 Caterpillar 430F2

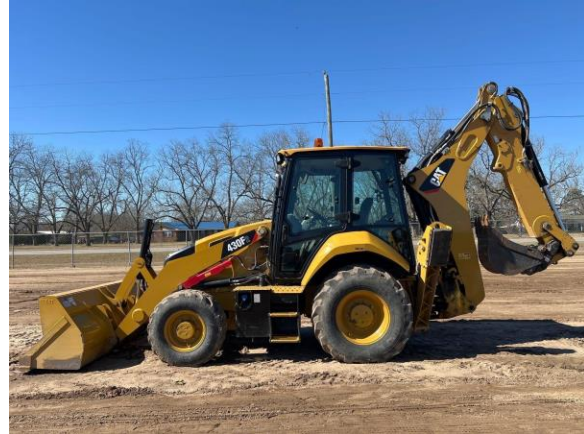
The 2018 Caterpillar 430F2 Backhoe Loader is in Good Condition (90%). This machine has been professionally maintained and shows minimal wear for its age and hours. All major components and systems were inspected, and no critical issues were found. Minor wear noted is consistent with normal operation and does not require immediate attention.
