Albatross Equipment Earthworks
10998 WY-789 Riverton, WY 82501
www.albatrossequipment.com

Inspection Checklist for 2019 CATERPILLAR 320

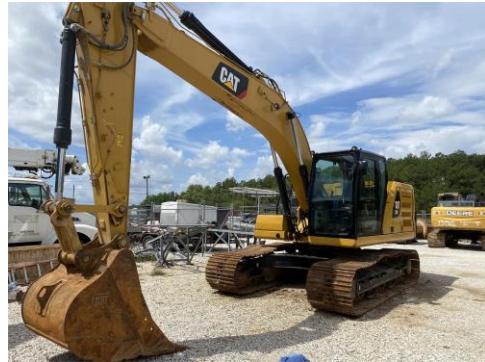
The 2019 Caterpillar 320 excavator has been thoroughly inspected and is in **good condition**. All major components and systems are operational, with minor wear consistent with machine hours and usage. No immediate repairs or maintenance are required at this time.
