**Albatross Equipment Earthworks**  
10998 WY-789 Riverton, WY 82501  
[www.albatrossequipment.com](http://www.albatrossequipment.com)

## Inspection Checklist for 2019 DEERE 135G

### General Machine Information

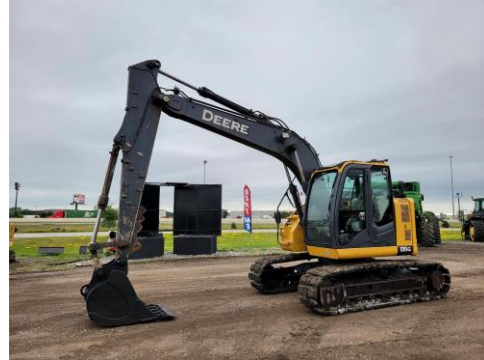
- - Model: 2019 DEERE 135G
- - Machine Hours: 2,680 hours
- - Condition: Good condition
- - Features:
  - - - Enclosed cab
  - - - 9'6" stick
  - - - Pattern changer
  - - - Auxiliary hydraulics
  - - - 33" digging bucket
  - - - 20" rubber tracks
