**Albatross Equipment Earthworks**  
10998 WY-789 Riverton, WY 82501  
[www.albatrossequipment.com](http://www.albatrossequipment.com)

## **Inspection Checklist for 2020 DEERE 85G**

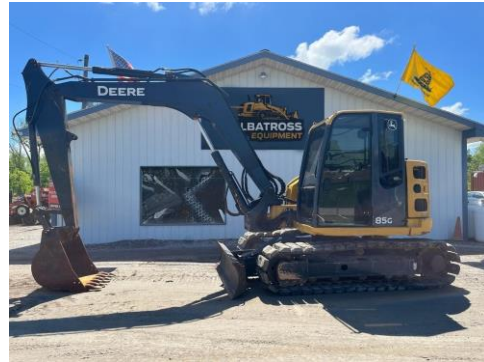
- Model: 2020 DEERE 85G
- Machine Hours: 1,337 hours
- Condition: Good condition
- Specifications:
  - Enclosed cab with heat, air, and radio
  - 2-speed travel
  - Auxiliary hydraulics
  - 84" backfill blade
  - 56.9 HP Yanmar diesel engine
  - 36" tooth bucket
  - 17.5" rubber tracks
  - 14'10" max digging depth
  - 19,244 lbs operating weight
