Inspection Checklist for 2018 DEERE 320G

Model: 2018 DEERE 320G

Hours: 519

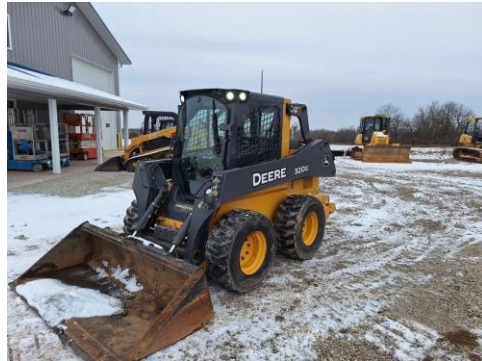
Condition: Good

This **2018 DEERE 320G** is in **good condition**, with all systems operational and no significant issues detected during inspection. Minor cosmetic wear is consistent with machine hours and does not impact performance.
