Inspection Checklist for 2018 New Holland C232

Make & Model: 2018 New Holland C232

Machine Hours: 31

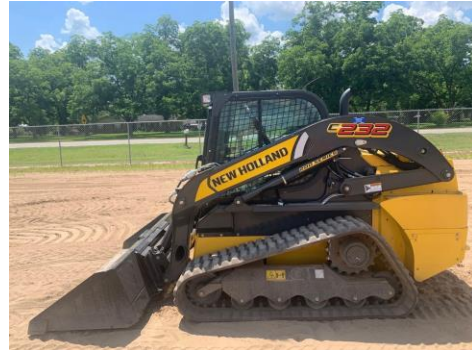
The 2018 New Holland C232 skid steer with only 31 machine hours is in **excellent condition**, showing minimal wear due to low usage. All systems and components inspected are fully functional, with no signs of mechanical or hydraulic issues. This machine is work-ready and suitable for immediate deployment.
