Inspection Checklist for 2018 DEERE 331G

- Model: 2018 DEERE 331G
- Hours: 875
- Condition: Good
- Key Features: EROPS, Heat & Air, Radio, Rear Camera, SJC Controls, 2-Speed Travel, Auxiliary Hydraulics, 91 HP Yanmar Diesel Engine, Hydraulic Quick Attach, New 84" Heavy-Duty Bucket, 18" Rubber Tracks, 3,100 LB Lift Capacity, Operating Weight: 11,900 lbs

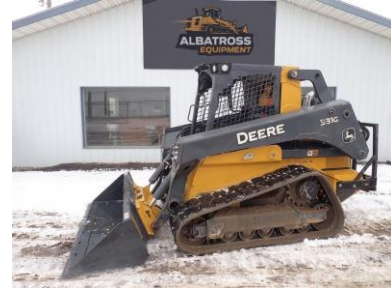
The 2018 DEERE 331G is in good condition. The machine shows typical wear for its age and hours but is fully operational and work-ready. Key components, including the hydraulic system, tracks, and engine, have been well-maintained. The addition of a new 84" heavy-duty bucket ensures the equipment is ready for immediate use. Minor cosmetic wear does not affect functionality.
