Inspection Checklist for 2019 DEERE 314G

Condition: Good
Machine Hours: 33.8 Hours

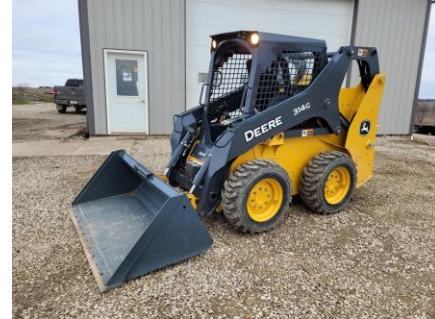
The 2019 DEERE 314G Skidsteer has been thoroughly inspected and is in **good condition**. All critical systems, including the loader arm assembly, hydraulic system, engine, and tires, are functioning as intended with no major issues identified. Minor wear is consistent with machine hours and does not impact operational performance. This skidsteer is ready for immediate use.
