Albatross Equipment Earthworks
10998 WY-789 Riverton, WY 82501
www.albatrossequipment.com

Inspection Checklist for 2019 DEERE 317G

Model: 2019 DEERE 317G

Hours: 162

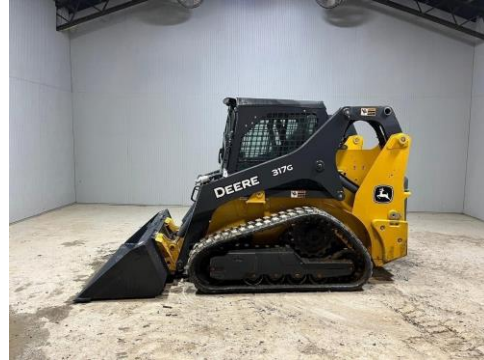
The 2019 DEERE 317G is in good condition and fully operational. With only 162 hours of use, the equipment shows minimal wear and has been well-maintained. The new 72" bucket and 90% track life enhance its overall usability and value. All systems, including hydraulics, engine, and operator controls, are functional and meet manufacturer specifications.
