Albatross Equipment Earthworks
10998 WY-789 Riverton, WY 82501
www.albatrossequipment.com

Inspection Checklist for 2019 DEERE 325G

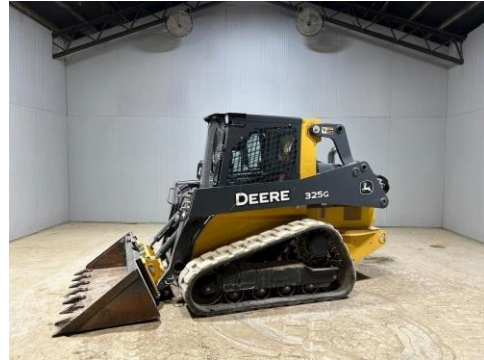
The 2019 DEERE 325G is in good working condition. All major systems are functional, with no immediate maintenance needs. Minor wear consistent with machine hours and application. Ready for operation.
