Inspection Checklist for 2019 Kubota SVL95-2S

- Make and Model: 2019 Kubota SVL95-2S
- Machine Hours: 962
- Condition: Good

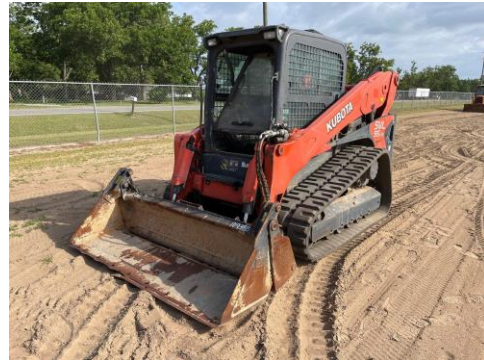
The 2019 Kubota SVL95-2S is in good condition, consistent with the recorded 962 hours of use. Minor cosmetic wear does not affect performance or safety. The machine is work-ready, with all systems fully operational and requiring no immediate repairs or maintenance.
