Inspection Checklist for 2021 Kubota SVL95-2S

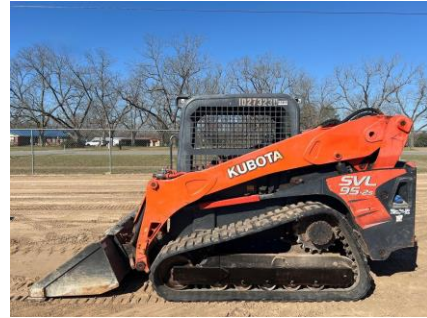
The 2019 Kubota SVL95-2S is in good condition with no significant mechanical or structural issues. Minor cosmetic wear is consistent with age and usage. The machine is work-ready and fully operational, with all major systems performing as expected. Rubber tracks, loader arms, and the hydraulic system are in excellent shape, ensuring reliable performance.
