Inspection Checklist for 2019 New Holland C245

Equipment Details: 2019 New Holland C245
Machine Hours: 792 Hours
Condition: Good (90% Excellent)

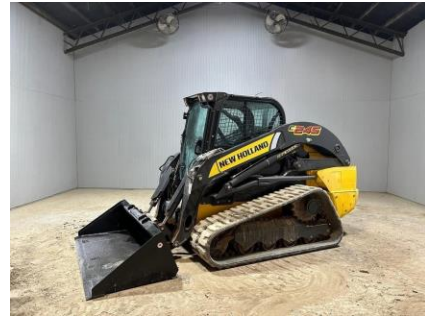
This 2019 New Holland C245 skid steer is in **excellent condition** with **90% overall health**. The machine shows minimal wear for its age and hours, with **all major systems and components fully operational**. The addition of a brand-new 78" general-purpose bucket enhances its work-ready status. No immediate repairs or maintenance are required beyond standard servicing intervals.
