Inspection Checklist for 2019 Takeuchi TL8

Model: 2019 Takeuchi TL8
Machine Hours: 1242

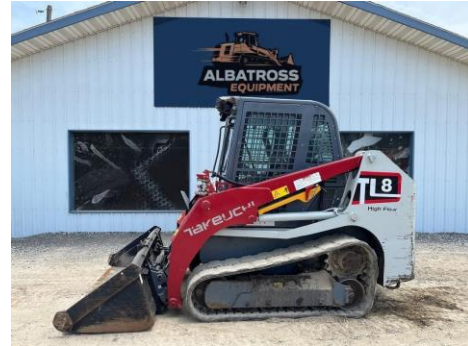
The 2019 Takeuchi TL8 with 1242 machine hours is in **good condition**, exhibiting minimal wear consistent with its hours of operation. All systems, including the engine, hydraulics, and cab features, are fully operational. No significant repairs or maintenance are required at this time. Regular maintenance is recommended to preserve performance and reliability.
