Albatross Equipment Earthworks
10998 WY-789 Riverton, WY 82501
www.albatrossequipment.com

Inspection Checklist for 2019 DEERE 325G

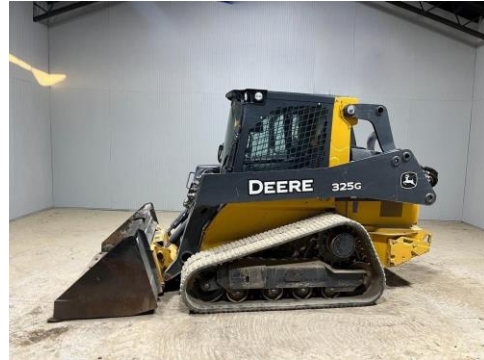
The 2019 DEERE 325G is in good condition, with minor wear consistent with its 1,715 operational hours. The machine is well-maintained, with all critical components functioning as intended. Tracks, hydraulic system, and engine are in excellent working order. No repairs are currently needed, making this Skidsteer work-ready.
