Inspection Checklist for 2019 John Deere 332G

Model: 2019 DEERE 332G

Hours: 1,144

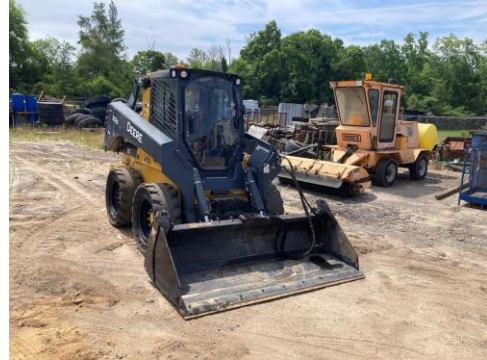
Condition: Good (Very good overall condition)

The 2019 DEERE 332G Skidsteer is in very good condition with minimal wear consistent with 1,144 hours of operation. All systems have been inspected and are operational without any major issues or safety concerns. This machine is work-ready and meets industry standards.
