Inspection Checklist for 2020 DEERE 320G

Machine Hours: 355

Condition: Good

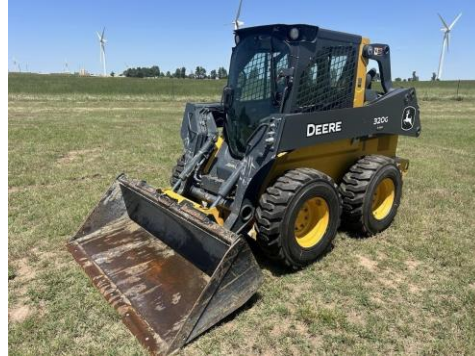
Additional Features: Cab with AC & heat, pilot controls, very nice overall condition.

The 2020 DEERE 320G Skidsteer with 355 hours is in **good condition**, reflecting regular maintenance and light usage. The machine is mechanically sound, with no significant defects or immediate maintenance needs. Cab climate control, pilot controls, and hydraulic systems are fully functional. Loader arms and tires show minimal wear, ensuring reliability and efficiency for future operation.
