Inspection Checklist for 2020 DEERE 333G

Model: 2020 DEERE 333G
Machine Hours: 1,059
Condition: Good

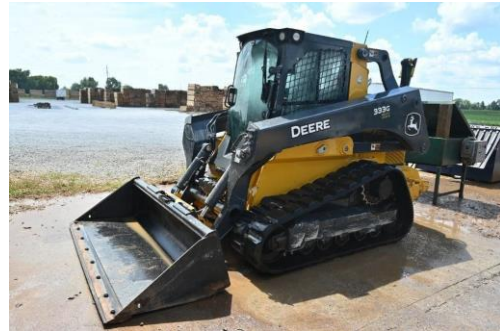
- **Visual Condition:** Machine exterior shows normal wear consistent with hours. No significant dents, scratches, or corrosion observed.
- **Cleanliness:** Equipment cleaned and free of excess dirt or debris.
