Inspection Checklist for 2020 New Holland C245

Skidsteer Model: 2020 New Holland C245
Machine Hours: 434
Condition: Good

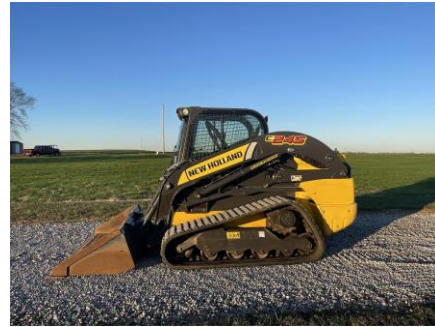
The 2020 New Holland C245 skid steer with 434 hours is in **good condition** and ready for work. The tracks are at 90%, and all systems, including hydraulics, operator controls, and safety features, are fully operational. Regular maintenance has been performed, and no major repairs are needed at this time.
