## Inspection Checklist for 2020 TAKEUCHI TL10V2

**Model:** 2020 TAKEUCHI TL10V2  
**Machine Hours:** 236  
**Condition:** Good

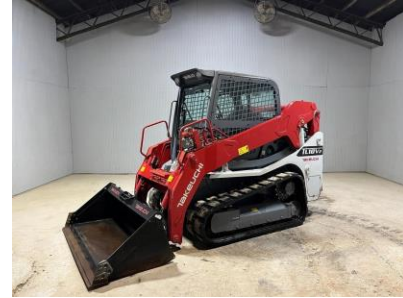
The 2020 TAKEUCHI TL10V2 with 236 machine hours is in **excellent condition**. All systems, components, and features function as intended, with minimal signs of wear consistent with the machine's limited use. Routine maintenance has been performed, and no immediate repairs or adjustments are required. This machine is fully operational and work-ready.
