## Inspection Checklist for 2020 TAKEUCHI TL10V2

**Model:** 2020 TAKEUCHI TL10V2  
**Machine Hours:** 618  
**Condition:** Good

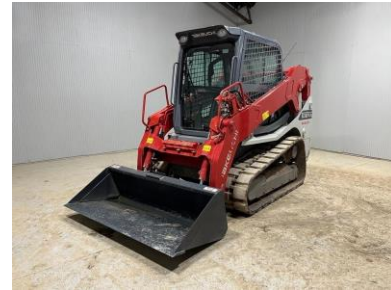
The 2020 TAKEUCHI TL10V2 skid steer with 618 hours is in **good condition**, demonstrating reliable performance with minimal cosmetic wear and no major mechanical issues. All systems, including the engine, hydraulics, undercarriage, and operator controls, function as intended. The new 72" heavy-duty bucket enhances the machine's operational capabilities. This skid steer is ready for immediate use in demanding applications.
