Inspection Checklist for 2020 Kubota SVL65-2

- **Model:** Kubota SVL65-2
- **Year:** 2020
- **Hours:** 754

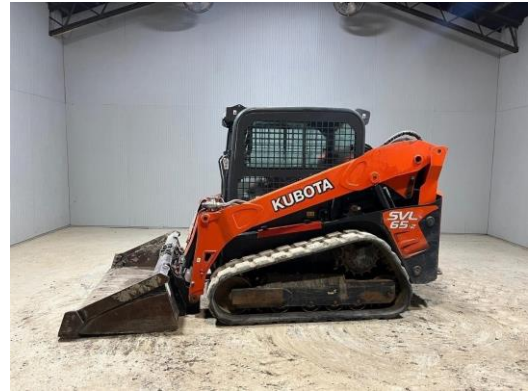
This 2020 Kubota SVL65-2 is in **good condition**, with only minor cosmetic wear consistent with 754 hours of use. All mechanical, hydraulic, and operator systems have been tested and are fully operational. The machine is **work-ready** with no significant repairs or maintenance required at the time of inspection.
