Inspection Checklist for 2021 DEERE 317G

Model: 2021 DEERE 317G

Machine Hours: 1,335

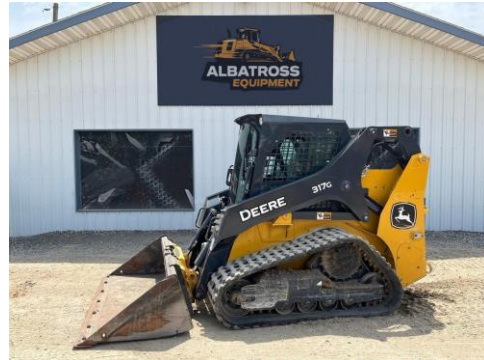
Condition: Good

- EROPS with Heat & Air Conditioning, Radio
- SJC Controls
- Auxiliary Hydraulics
- Rear Camera
- 61 HP Yanmar Diesel Engine
- 72" General Purpose Bucket
- Hydraulic SSL Quick Attach
- 16" Rubber Tracks
- 2,125 lbs Lift Capacity, 8,195 lbs Operating Weight
