Albatross Equipment Earthworks
10998 WY-789 Riverton, WY 82501
www.albatrossequipment.com

Inspection Checklist for 2021 DEERE 318G

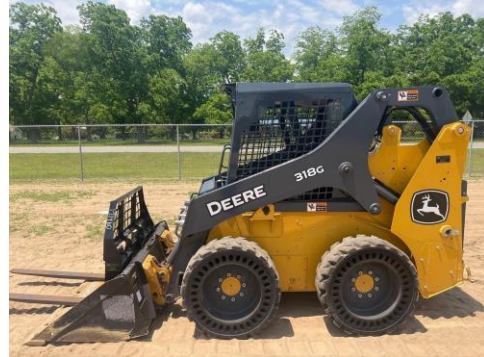
The 2021 DEERE 318G is in good condition, showing minimal wear consistent with its low hours (133). All major systems, including the engine, hydraulics, and controls, were

inspected and found to be operational. Minor cosmetic wear observed does not affect functionality.
