Albatross Equipment Earthworks
10998 WY-789 Riverton, WY 82501
www.albatrossequipment.com

Inspection Checklist for 2021 DEERE 318G

Make/Model: 2021 DEERE 318G

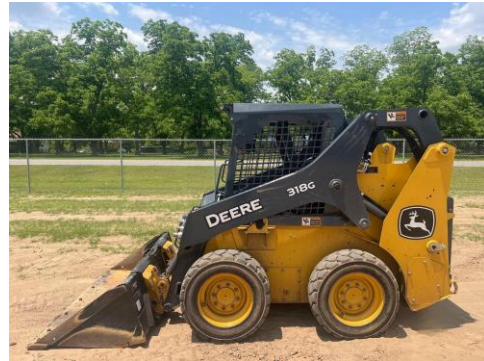
Hours: 332

Condition: Good

Features: OROPS, Quick Attach Bucket, Auxiliary Valves

The 2021 DEERE 318G Skidsteer with 332 hours is in good overall condition. All critical components have been inspected and found to be functional and within acceptable limits. Minor cosmetic wear is present but does not impact performance. This machine is well-maintained and ready for work.
